# AERIAL PHOTOGRAPHIC ANALYSIS WASTE DISPOSAL, INC., SITE Santa Fe Springs, California

## Report 2 - Hazardous Waste Site Characterization, Oil Reservoir, and Associated Land Parcels

EPA Region 9

TS-PIC-9809925S  
September 1998

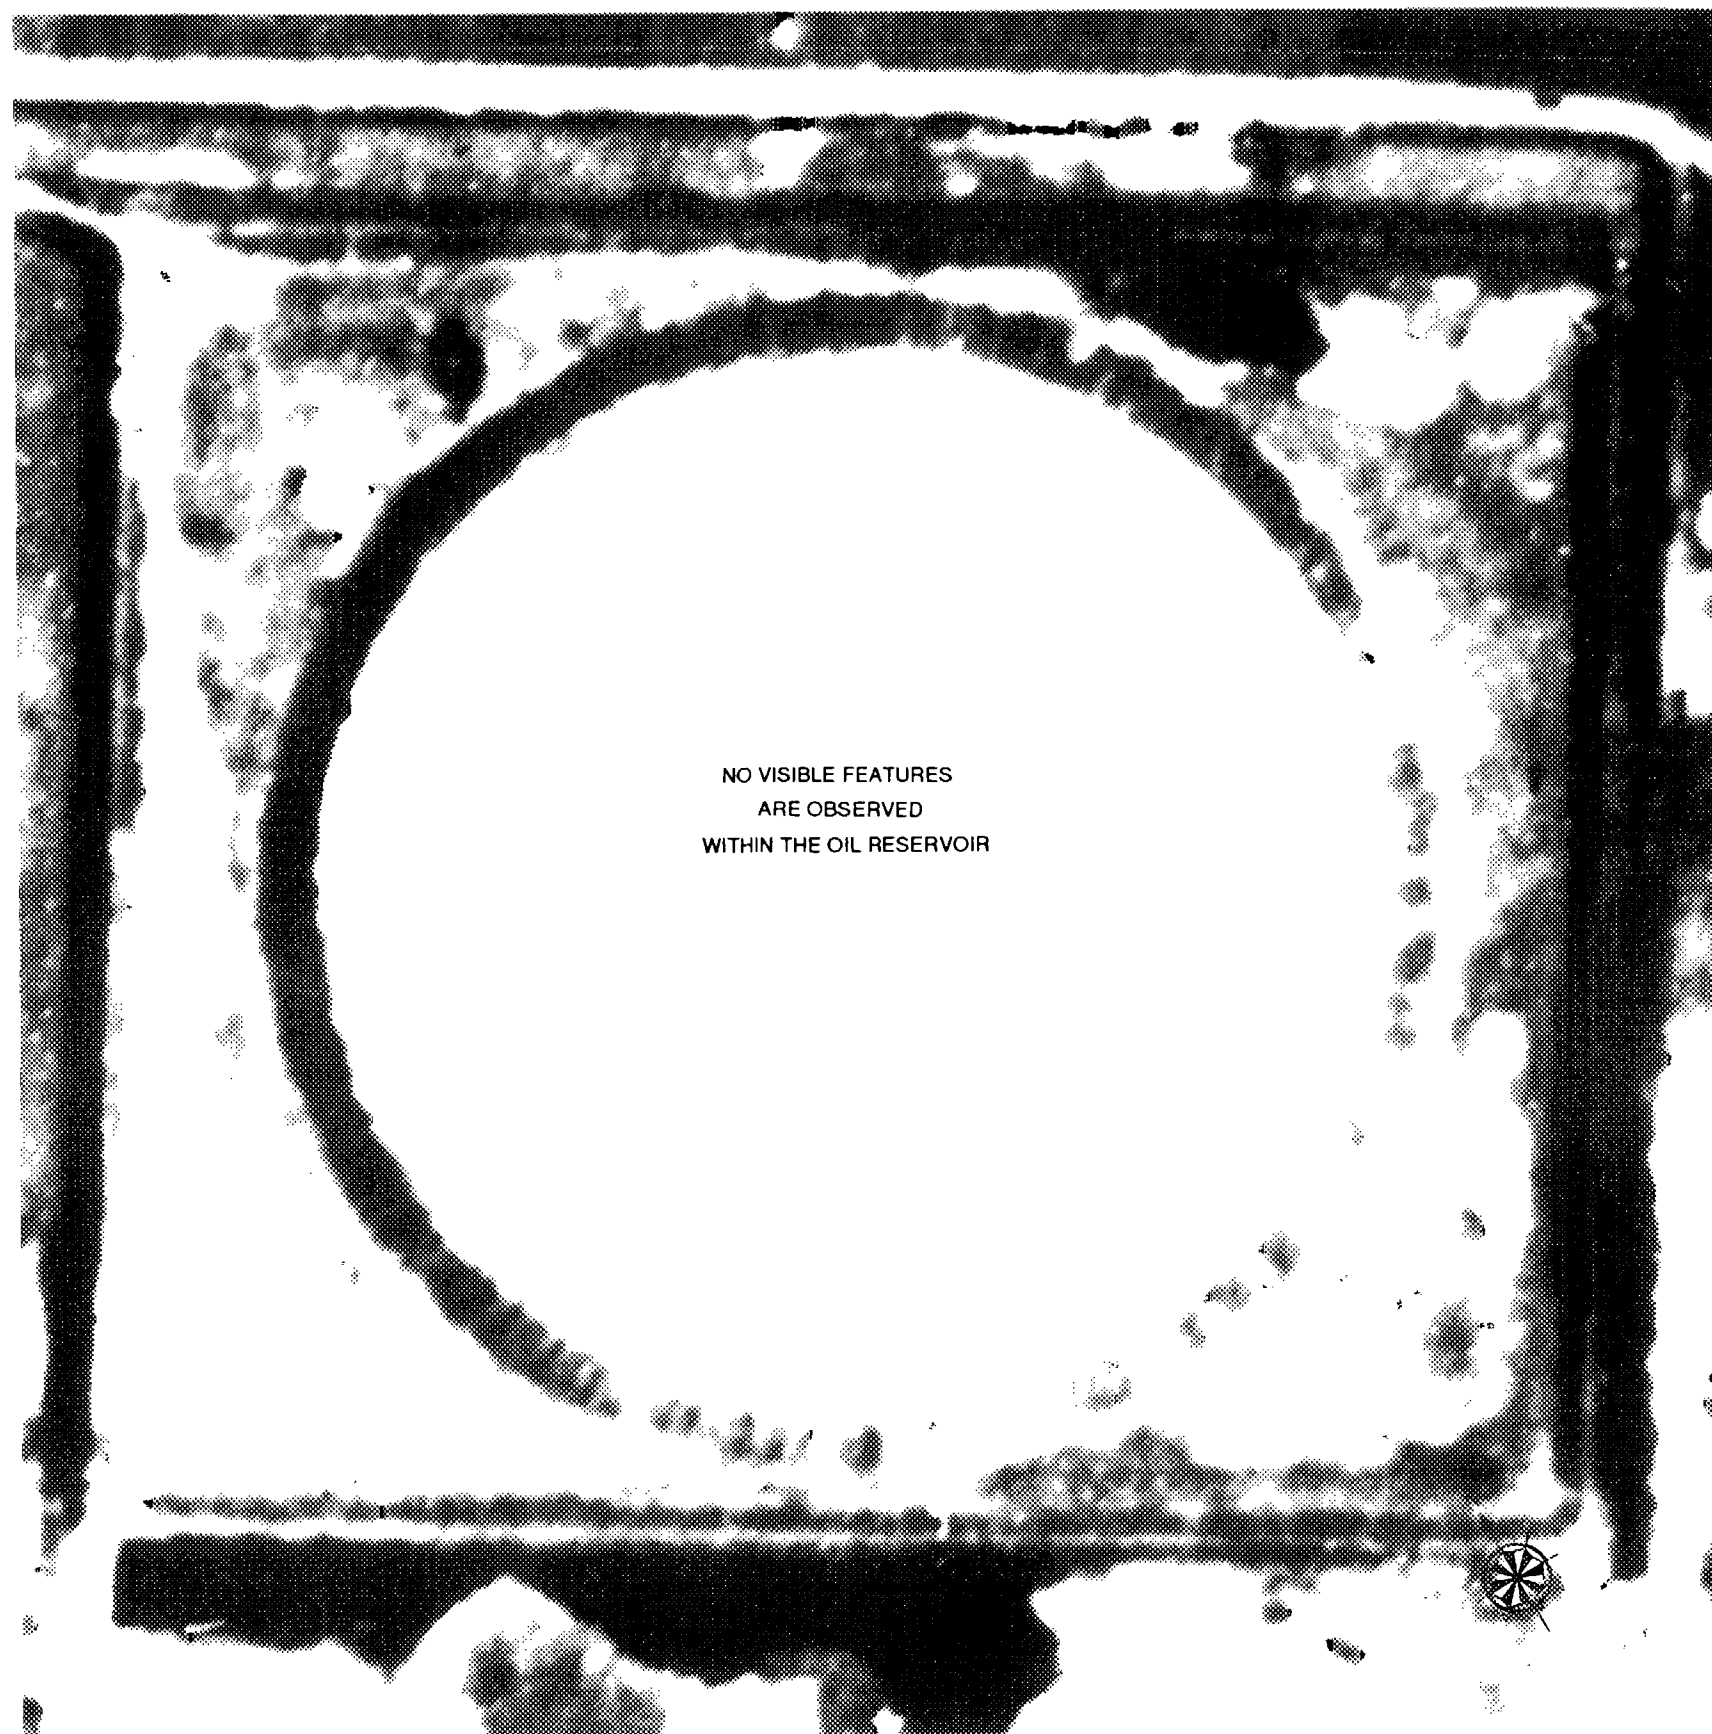
Figure 3. Waste Disposal, Inc., Oil Reservoir, 1928. Approximate scale 1:1,265.

No hazardous waste-related features are seen within the reservoir on this photograph.

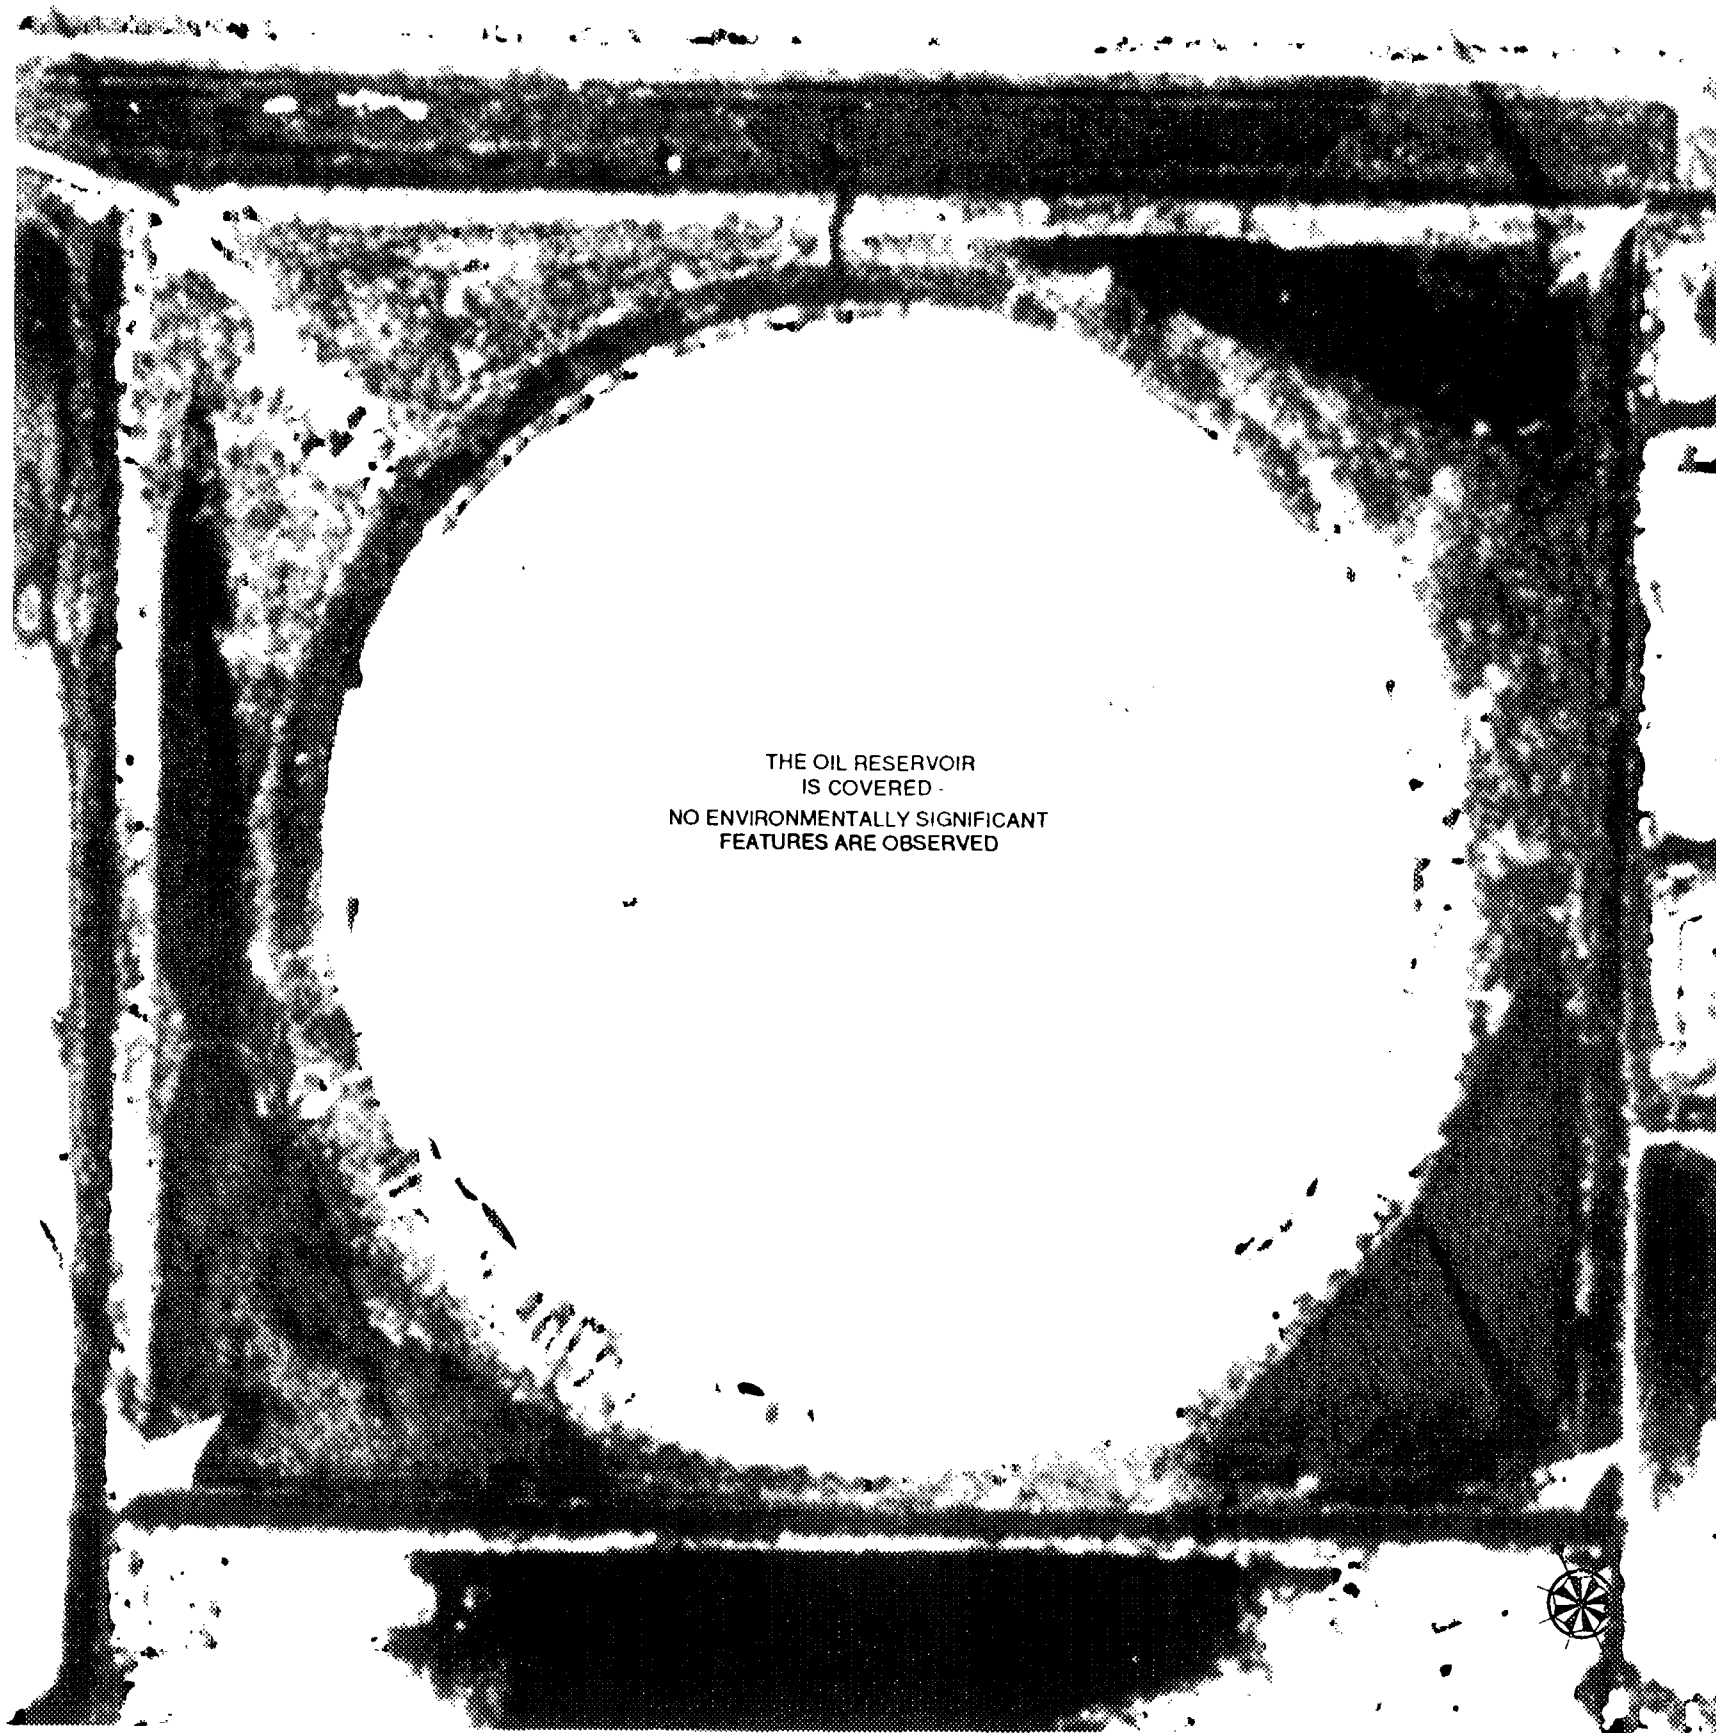
Figure 4. Waste Disposal, Inc., Oil Reservoir, February 20, 1937. Approximate scale 1:1,240.

No hazardous waste-related features could be observed within the oil reservoir because a cover has been constructed atop the reservoir.

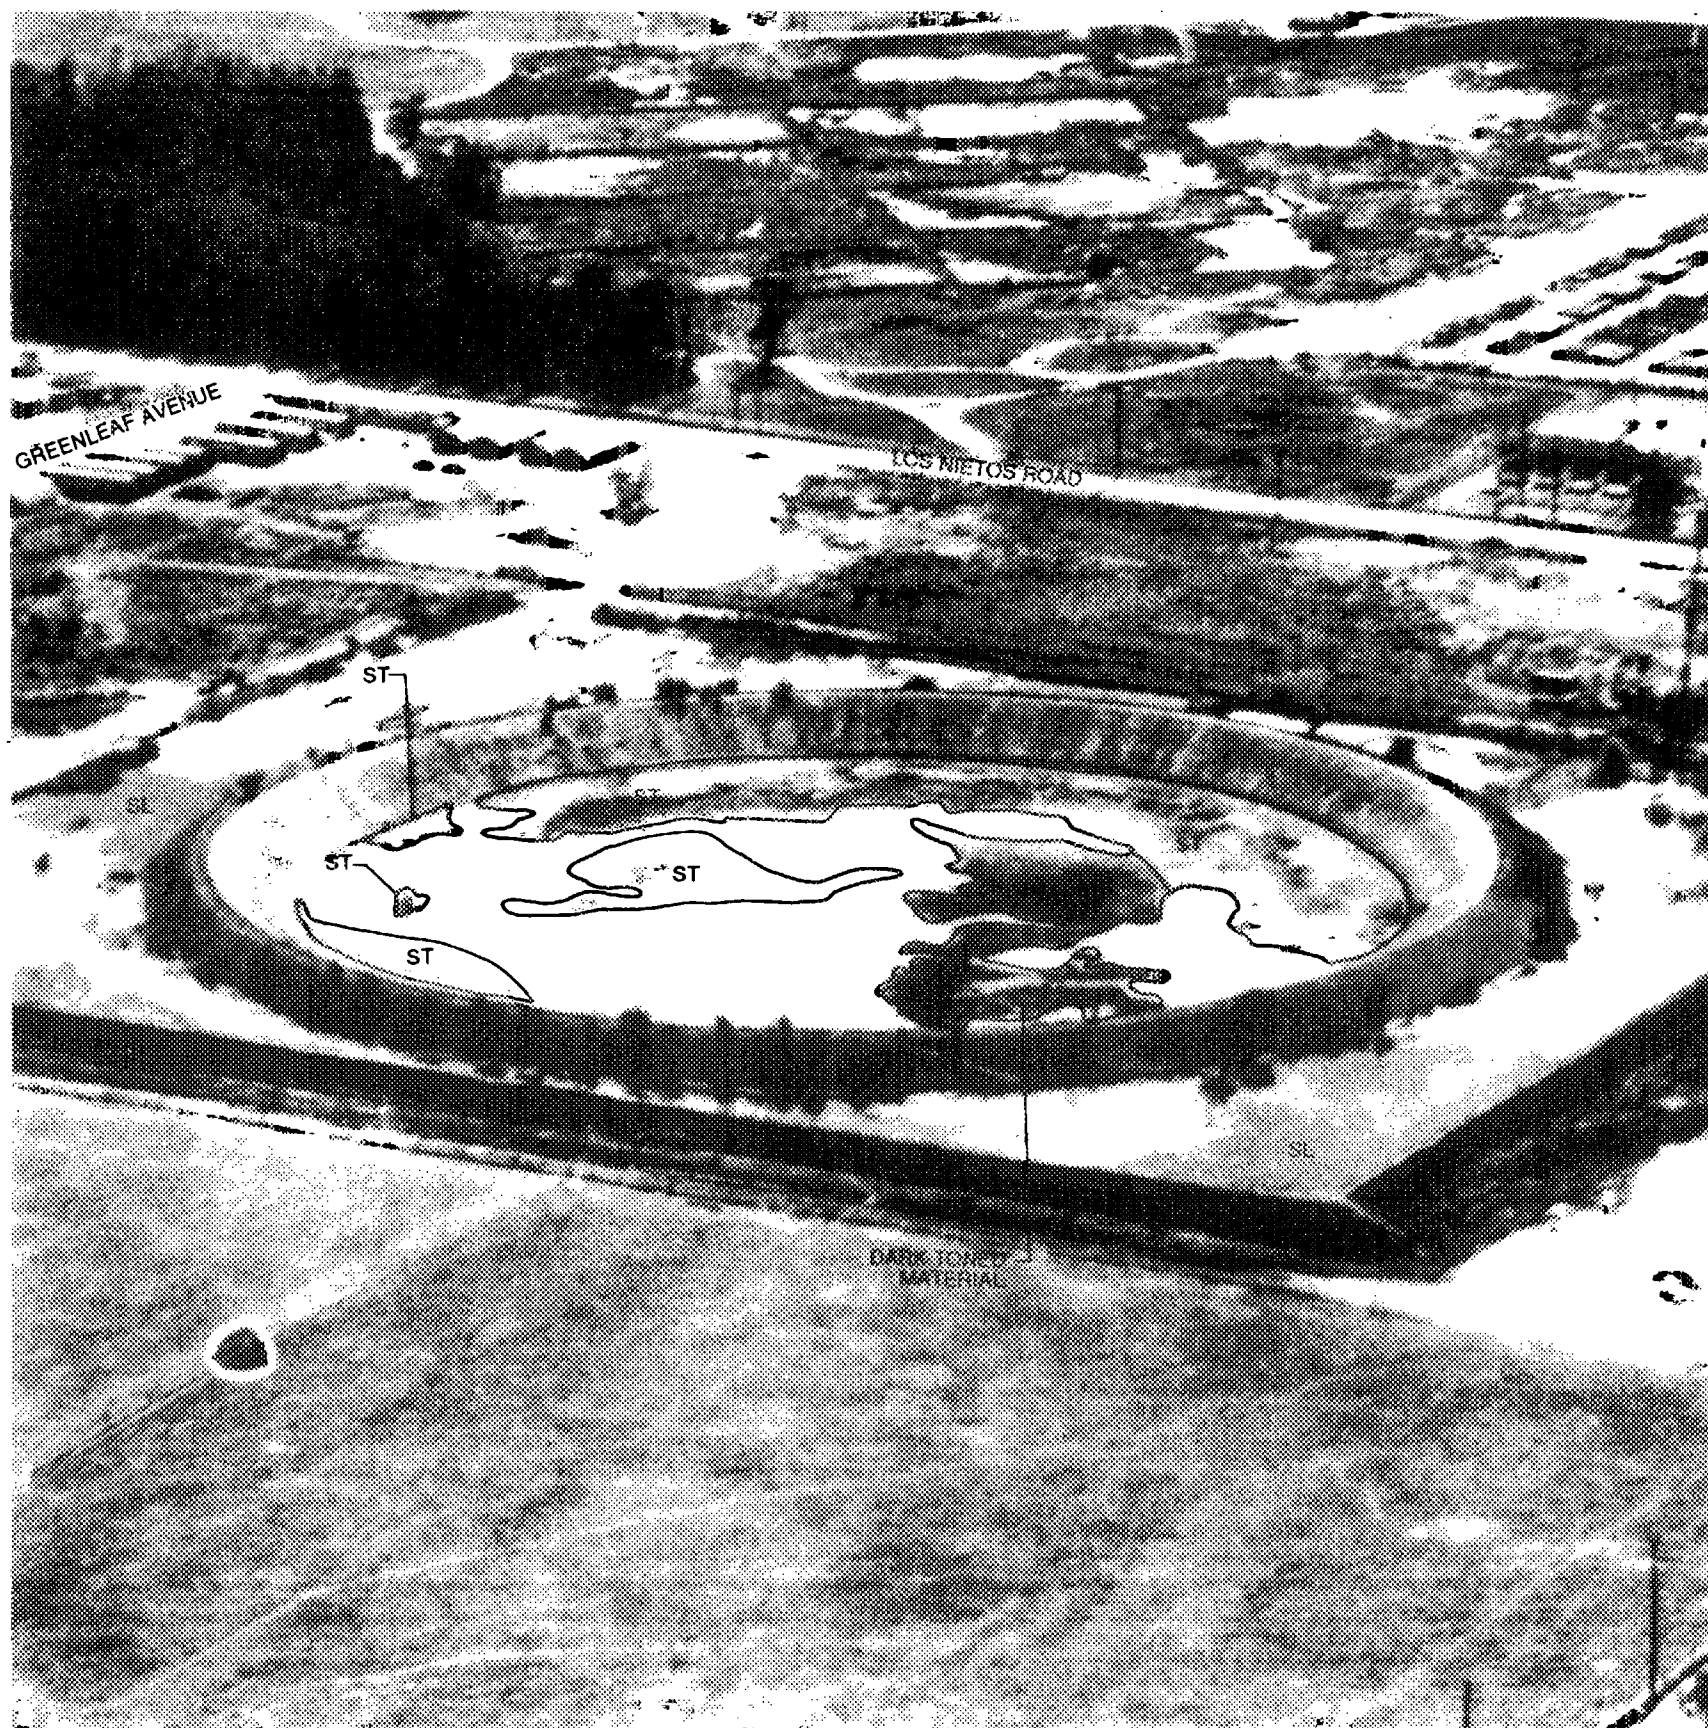
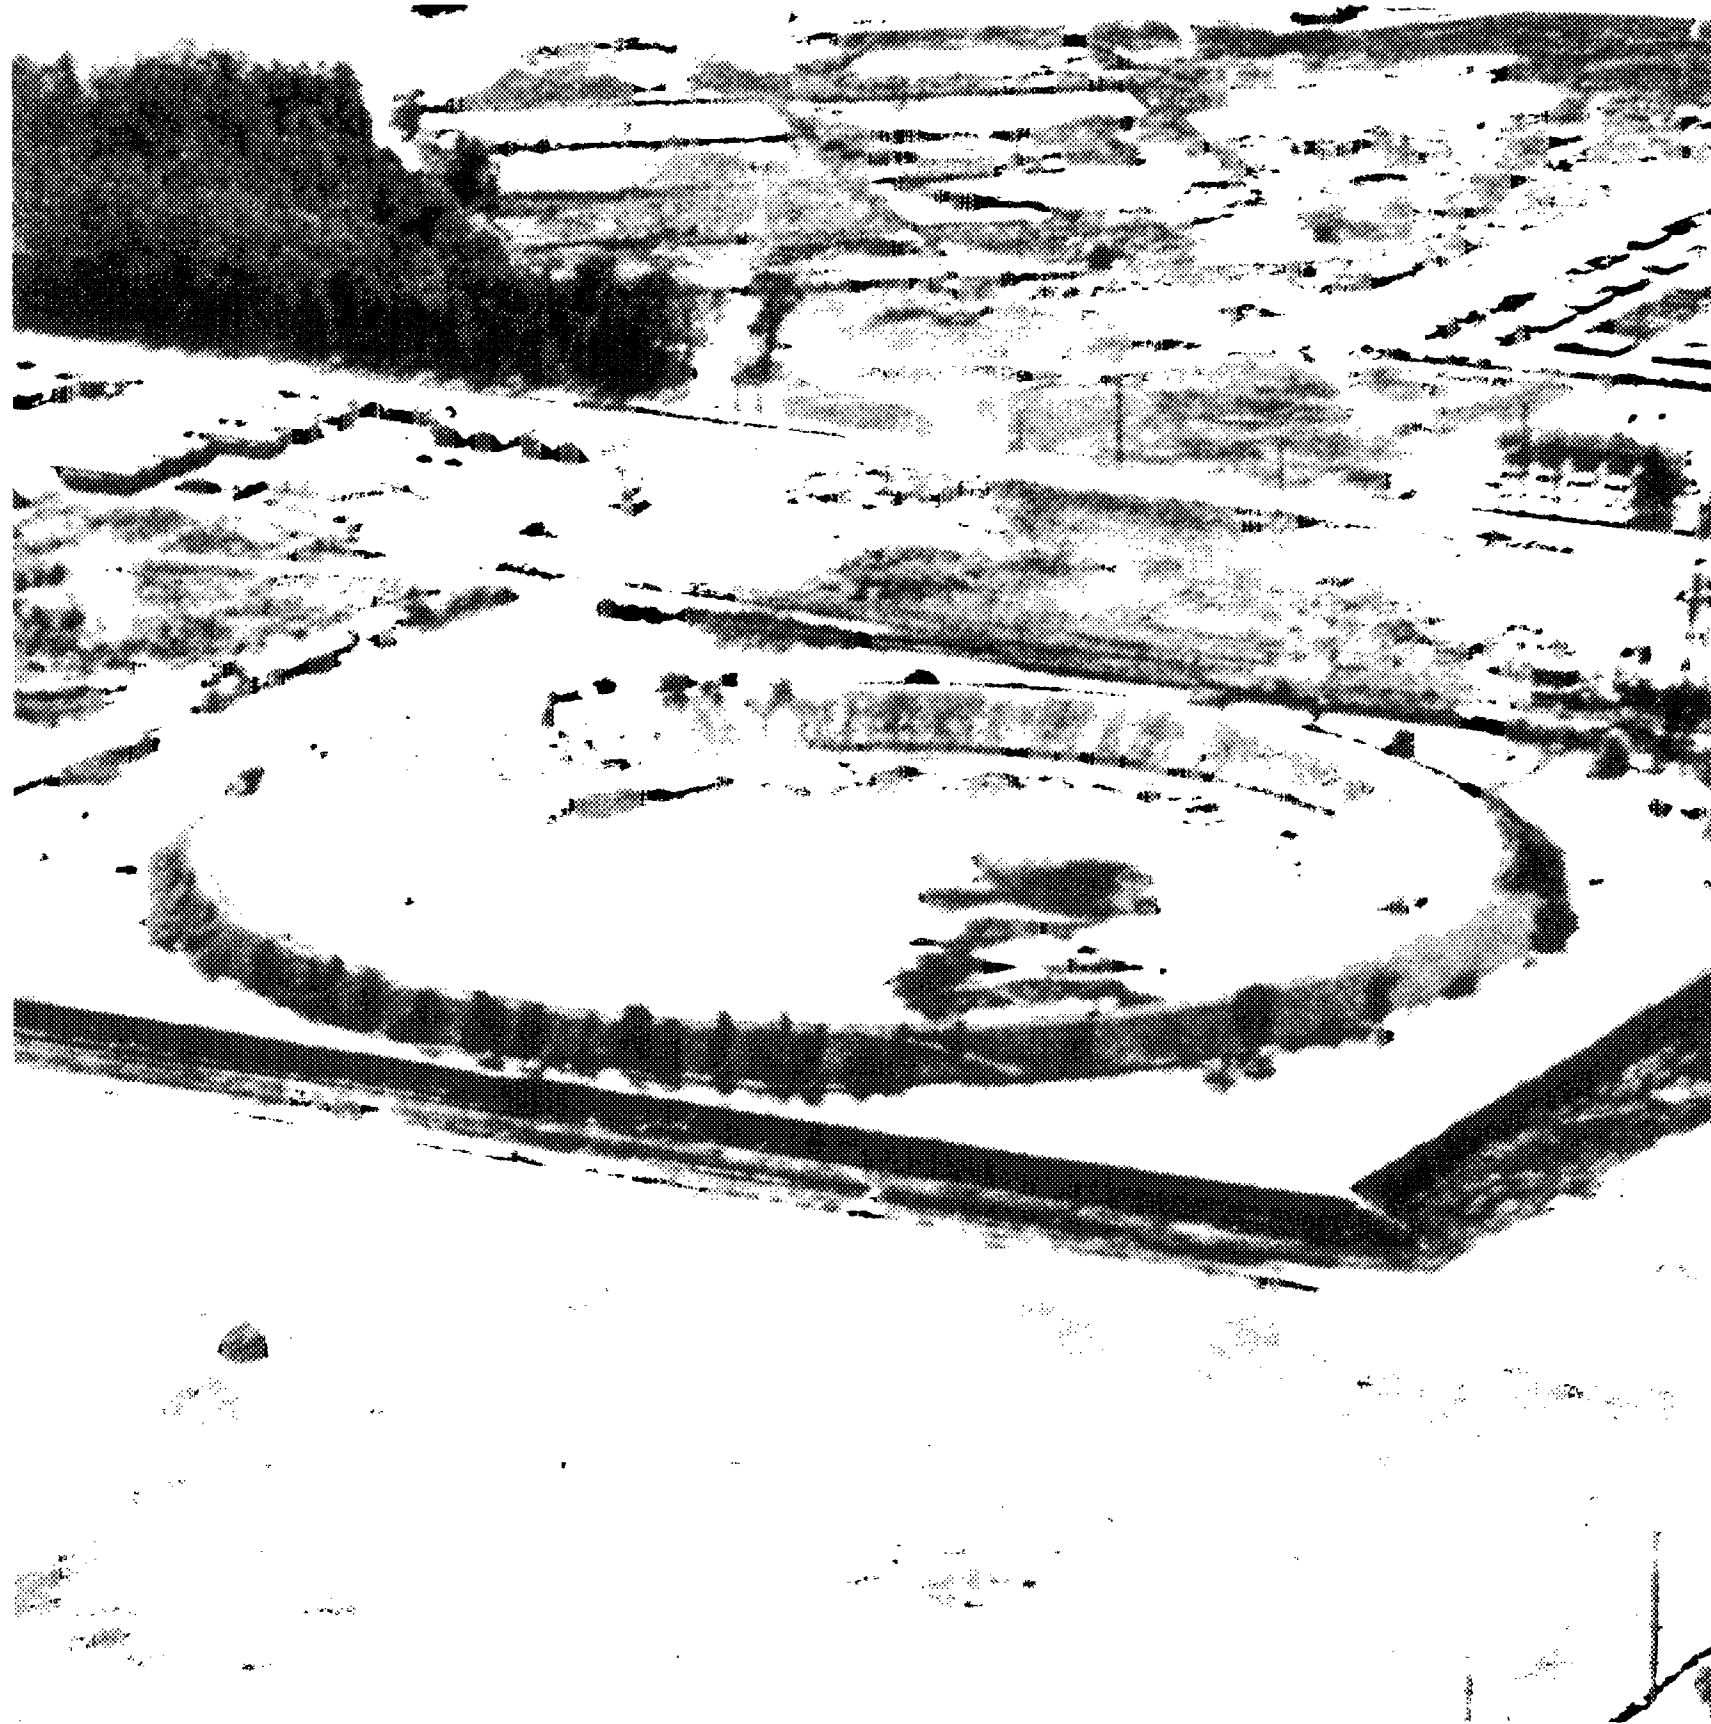
Figure 9. Waste Disposal, Inc., Oil Reservoir, October 6, 1951. Oblique view looking southwest. Scale varies.

This oblique aerial photograph shows that the oil reservoir contains standing liquid (SL), stains (ST), and dark-toned material.

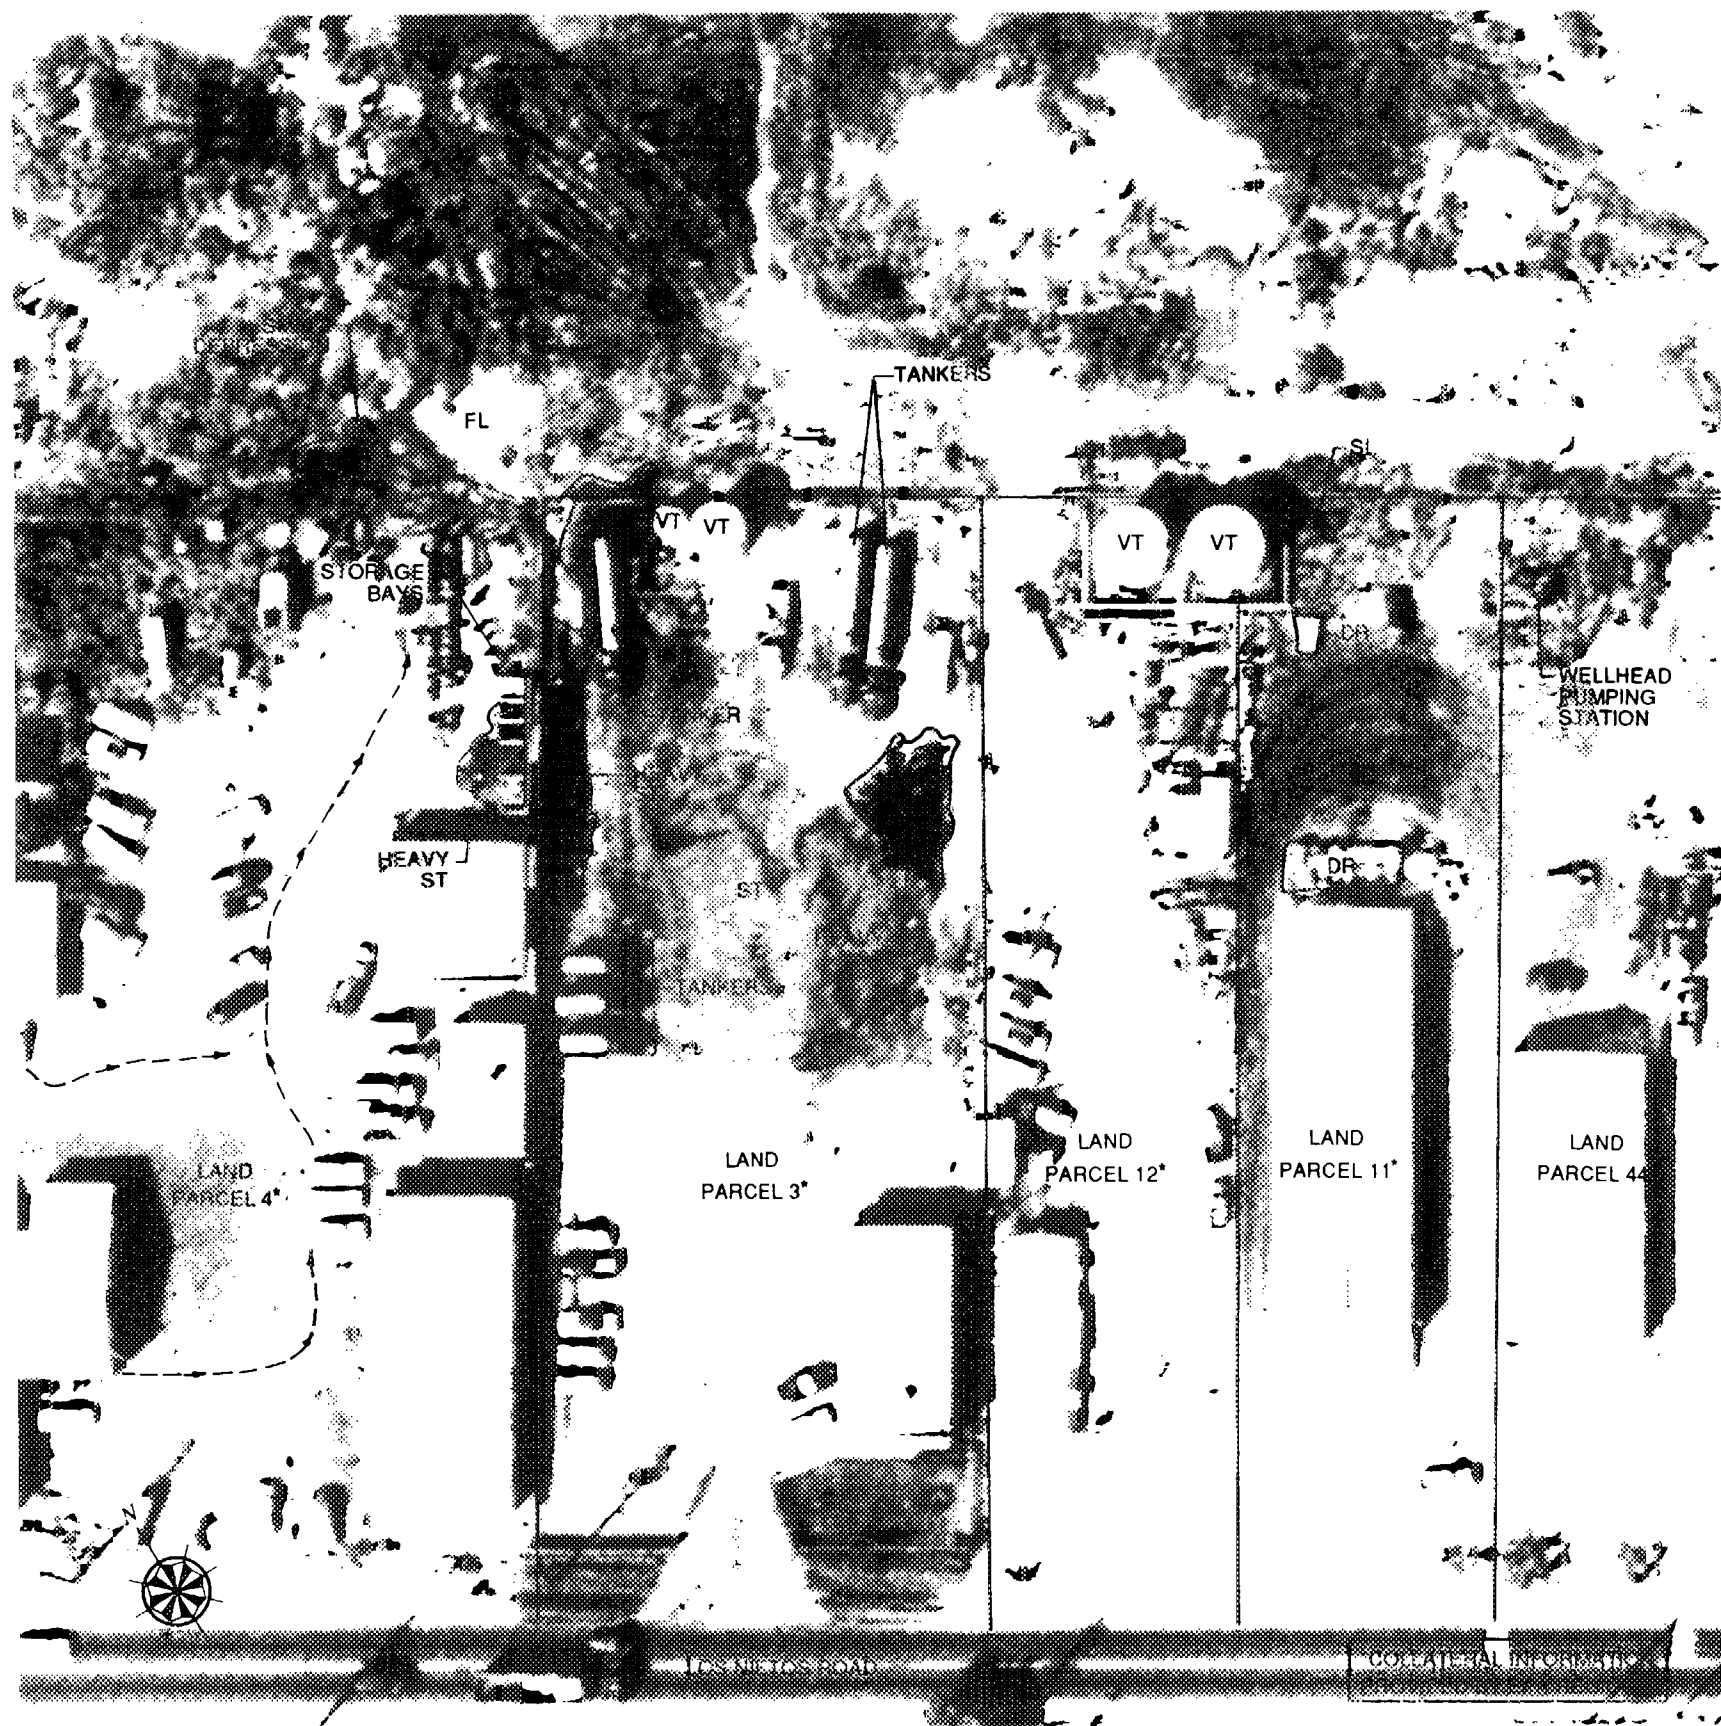
Figure 11. Waste Disposal, Inc., Land Parcels 3-44, August 9, 1955.  
Approximate scale 1:765.

Small drainageways are present on Land Parcel 4\*. They appear to originate at two buildings in the central portion of the parcel and flow to the northeast. A probable truck tanker transport company is located in Land Parcel 3. A large stain is seen in the facility lot and heavy stains and standing liquid are located at the northern corner. A small drainageway leads from this corner of Land Parcel 3 to a small depression where standing liquid is observed. Within Land Parcel 12\* are two large vertical storage tanks (VT). Three drum storage areas (DR) are present in Land Parcel 11\*. Standing liquid is visible outside the storage tank containment wall. To the southeast a wellhead pumping station is seen in Land Parcel 44\*.

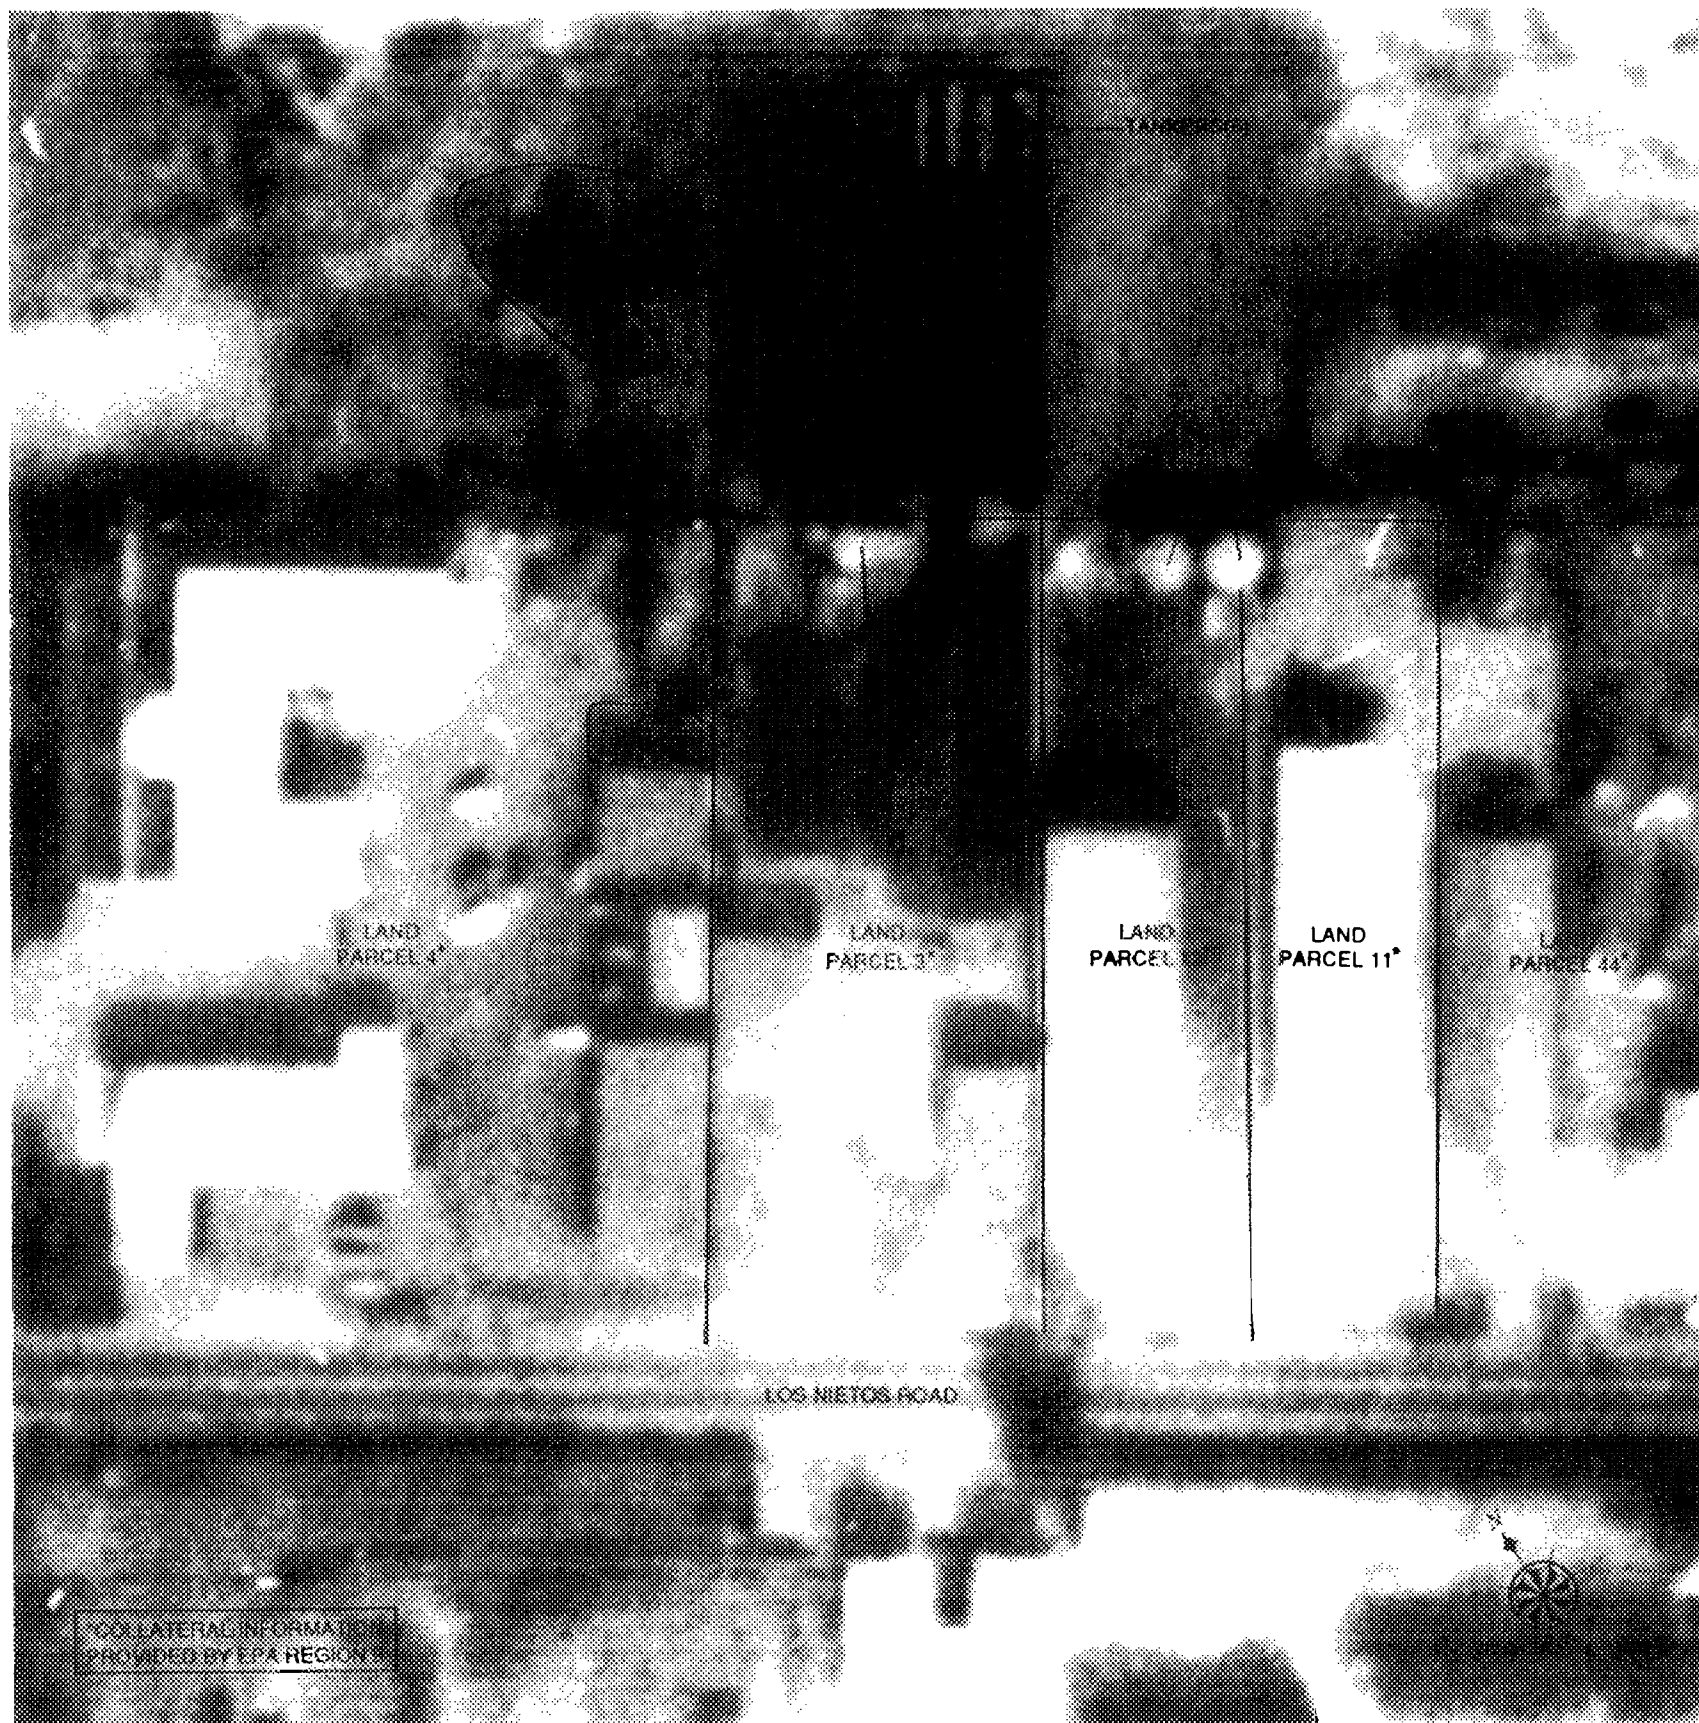
Figure 13. Waste Disposal, Inc., Land Parcel 3-44, December 2, 1962.  
Approximate scale 1:750.

At Land Parcel 4, staining continues to be present near the drum storage area seen in 1959. Standing liquid is present northeast of Land Parcel 4 where the stained ditch was noted in 1959. Staining is noted northeast of the standing liquid. Six tankers are parked at Land Parcel 24\*. Staining is visible throughout the northeastern portion of Land Parcel 3.

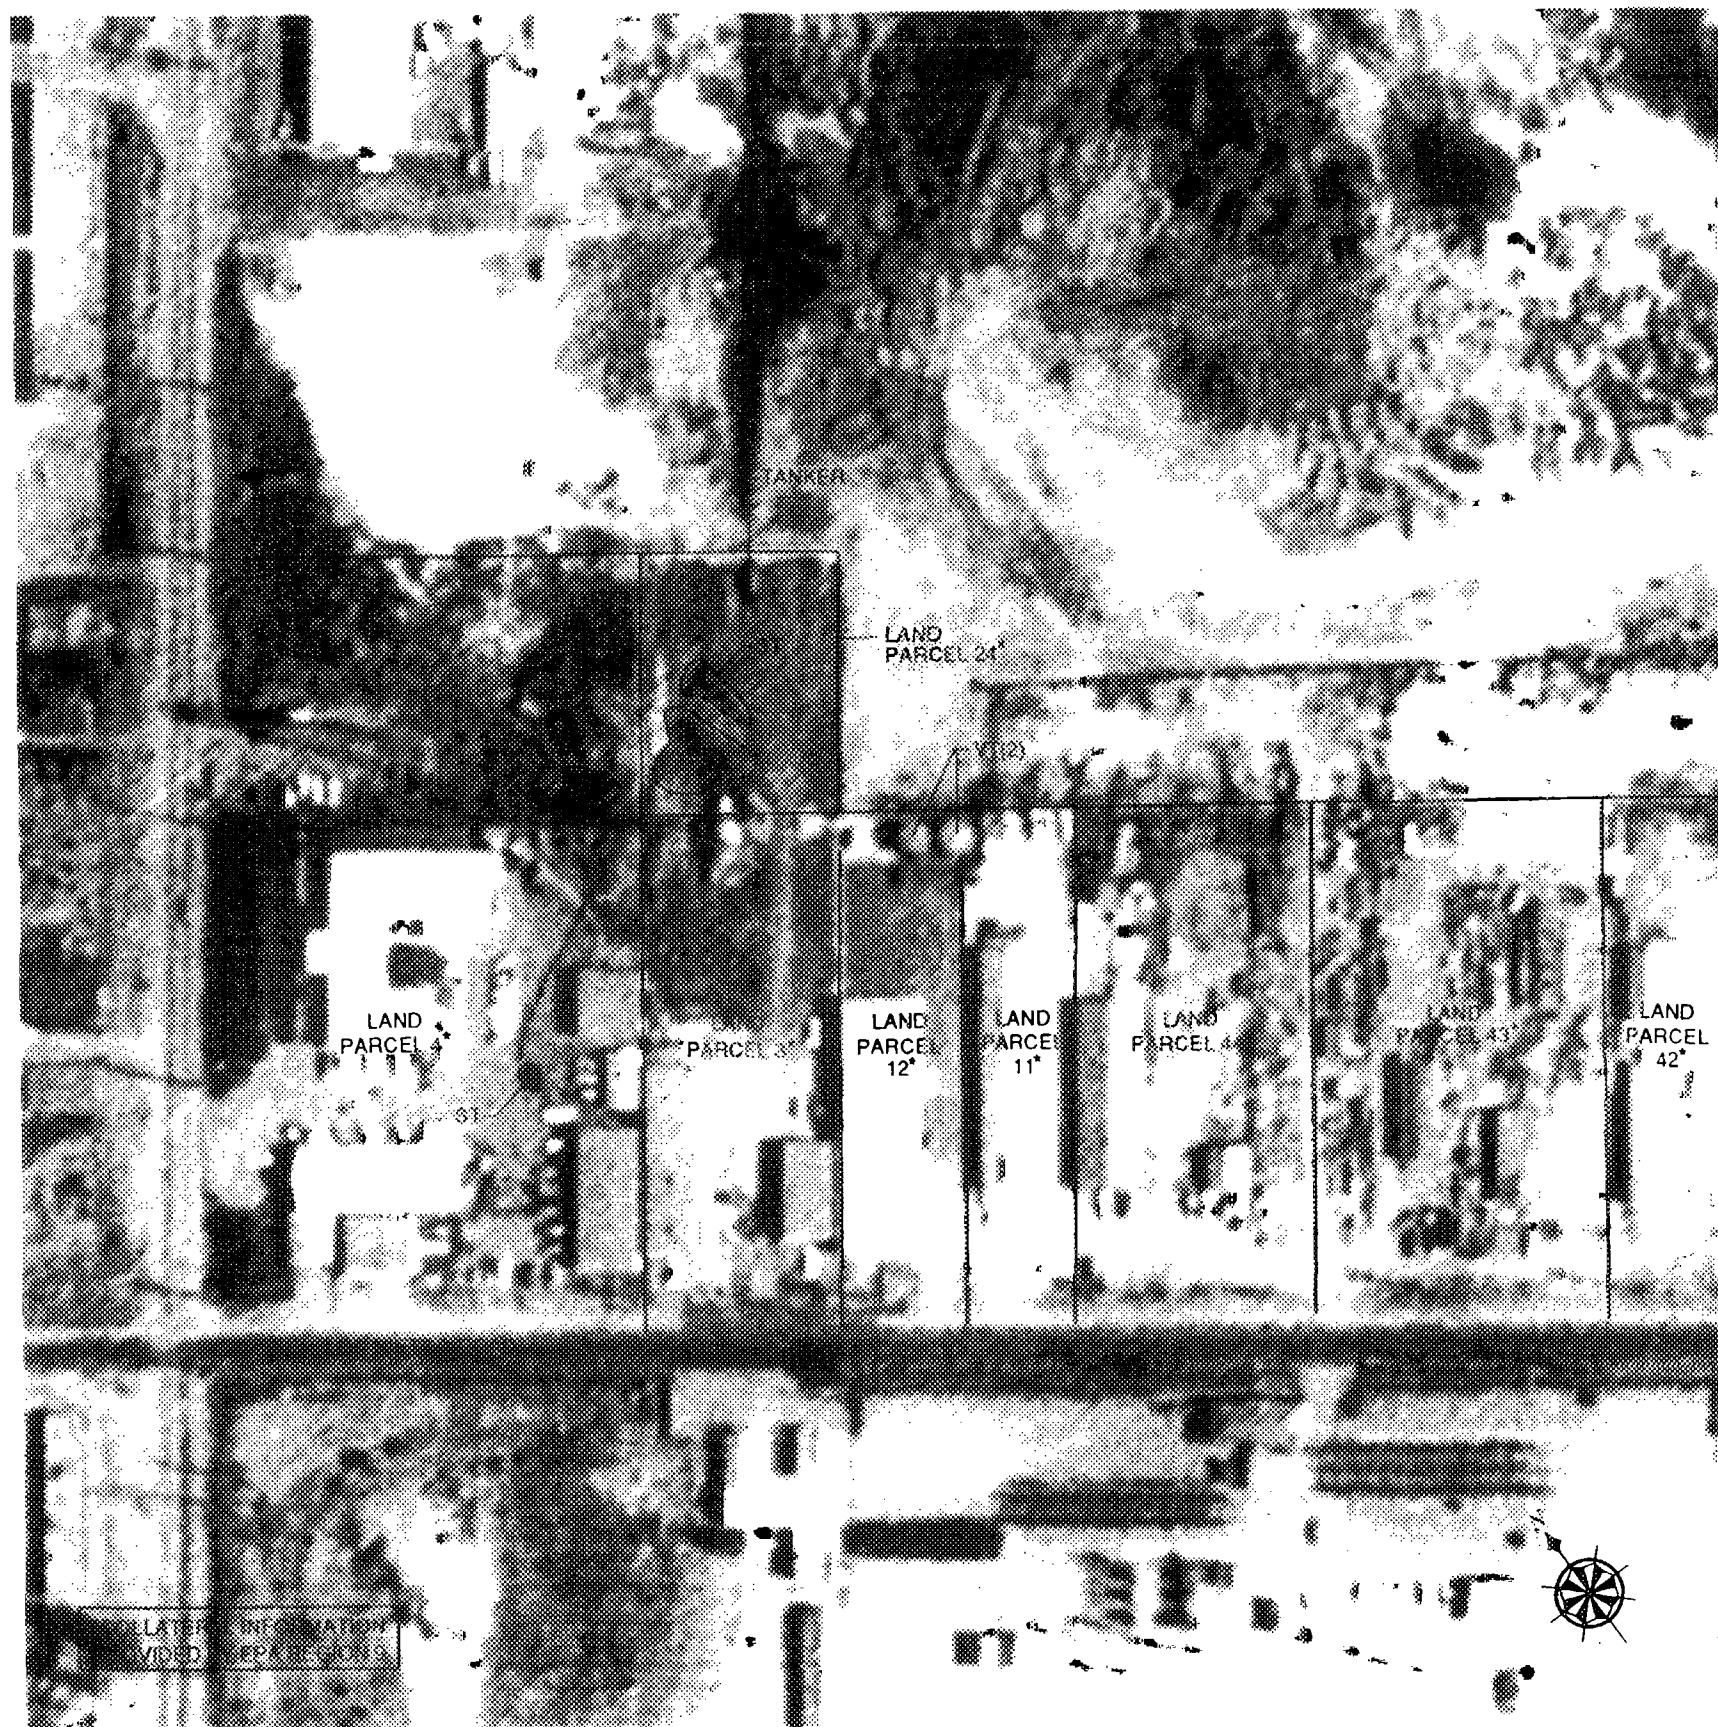
Figure 14. Waste Disposal, Inc., Land Parcels 3-44. February 28, 1963.  
Approximate scale 1:1,320.

A small stain is visible in the facility lot of Land Parcel 4. A small drainageway leads from the stain in a northeasterly direction. Standing liquid is observed in the same approximate location as seen in 1962. Within Land Parcel 24, one tanker and two stained areas are observed. The two stained areas are possibly related to the three vertical storage tanks in Land Parcel 3 (in 1959) when staining was observed. The three tanks appear to have been removed.
